# SLINGMAX® Technical Bulletin

## Cyclic-Tension and Break Test

TB# 9A  
Date August 17, 2006

Lab Log: L-06-110  
To: Mr. Paul Boeckman  
Subject: An evaluation of TPXC2500 x 4' Slingmax Twin Path Slings

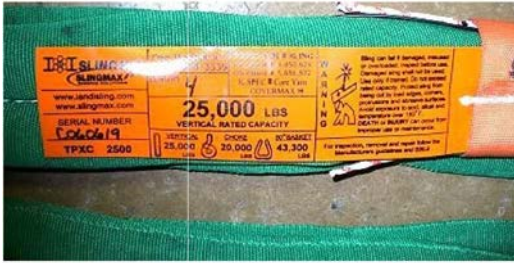
Close-up of tag on slings being tested

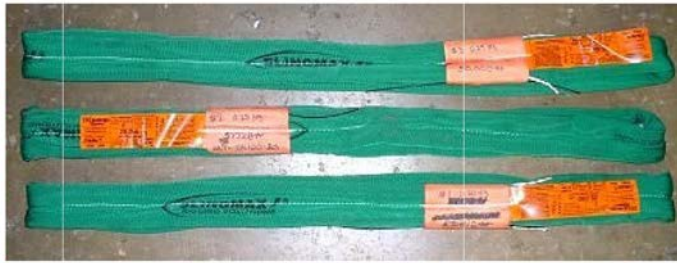
Photograph of the slings once testing had been completed

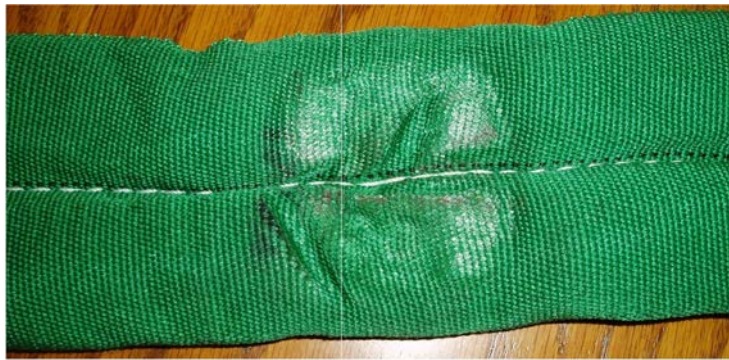
Photograph of the inside end of a sling after cycle testing had been completed

<u>Test No.</u>	<u>No. of Cycles</u>	<u>Time sling had cycled/Time of day</u>	<u>Results</u>
Serial No. C060619 – cycled at 2 seconds per cycle			
1	5,459 11,340 23,302 53,310	6 hrs. 39 min. - 3:16 PM	Sling slightly warm to the touch Fixture at shackle bolt fractured Temperature – 100.4 degrees F No failure. Outer material and most inner strands have hardened at shackle contact areas. Some inner strands along length of the sling have bunched together and stiffened. Sling appears to have stretched 1 1/4" in length.
Serial No. C060617 – cycled at 4 seconds per cycle			
2	2,129 47,818 51,728	2 hrs. 22 min. - 5:18 PM 4 hrs. 21 min. - 2:00 PM	Temperature – 92.2 degrees F Fixture at shackle bolt fractured Temperature – 91.6 degrees F No failure. Outer material and most inner strands have hardened at shackle contact areas. Some inner strands along length of the sling have bunched together and stiffened.

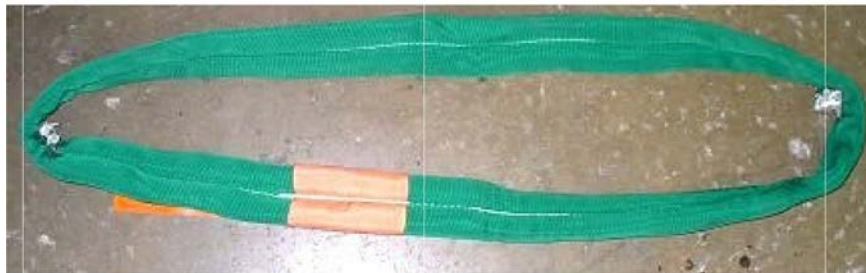
Sling no. 2 after ultimate load testing

Ultimate load = 105,100 lbs			Outer material torn at loading point on both ends. Inner strands fractured along length of sling.

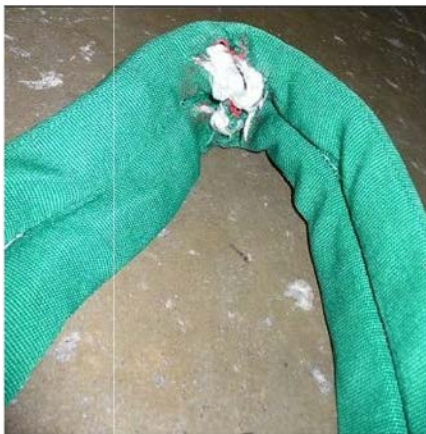
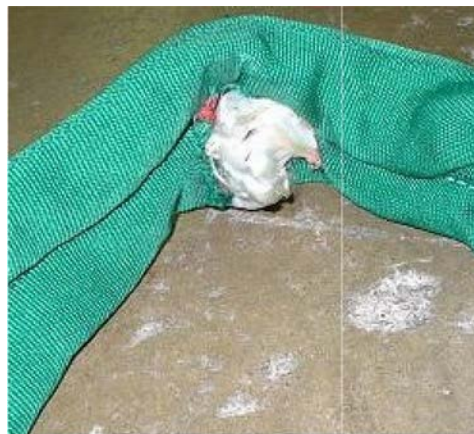
Close up of each end of sling no. 2 after ultimate load testing
